**Peabody District Court  
Peabody, MA**

# **HVAC SYSTEM EVALUATIONS COVID-19**

Office of Court Management  
November 9, 2021

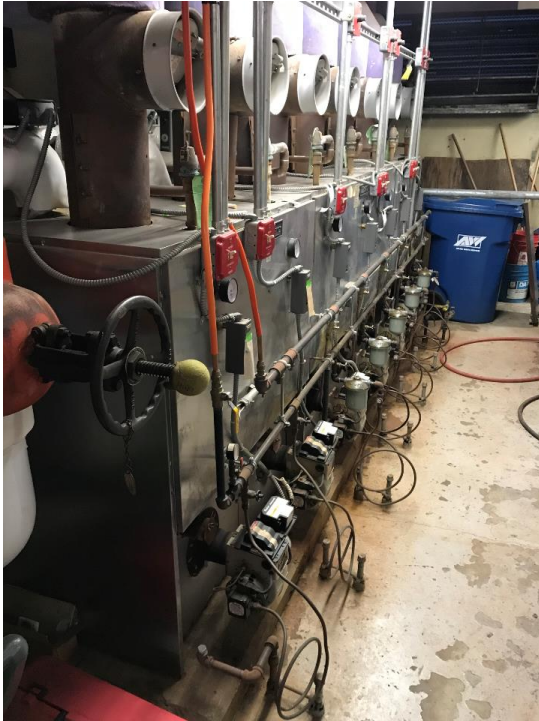
Photo 1 – Boiler

Hot water is provided by a 2,695 MBH, oil fired modular boiler with 7 modules installed in 2006. Chilled water is provided by a 30-ton air-cooled chiller installed on the roof in 2006. During the site visit facilities personnel mentioned that two of the seven modules are currently not operating due to mechanical deficiencies. Until recently only three modules had been operating but they were able to get two more back up and running. While this does not impact the COVID readiness of the building, this boiler is the only source of heat for the building and as such, is a critical piece of mechanical infrastructure. Tighe & Bond recommends investigating and addressing the deficiencies with the boiler system prior to the next heating season in Fall 2021.

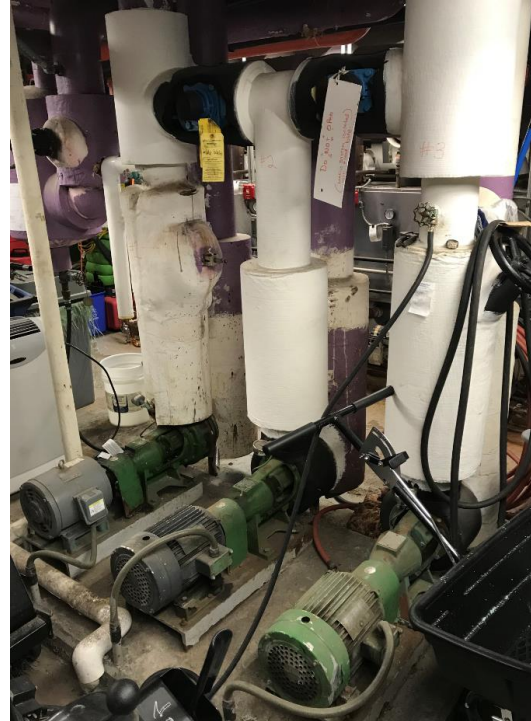
Photo 2 – Pumps

HW & CHW is pumped throughout the building by a set of (3) end suction pumps which are headered together. One pump distributes hot water to the heating system for reheat coils and fin tube radiation while the other serves the dual temp system for the fan coil units around the building perimeter. The pump in the middle is a standby pump which can serve either system as needed. These pumps are original to the building and well beyond their useful life.

The hot and chilled water pumps are constant flow systems. Constant flow pumps circulate the same volume of water to air handling units regardless of whether the water is required or not. If air handlers do not require this water, the three-way valves serving the air handler coils bypass the coil, which allows the water to return back to the chiller or boiler plant. We recommend investigating the possibility of converting these systems to variable flow. The three-way reheat and chilled water valves would have to be replaced with two-way valves, as well as any other three-way valves that are in the system. As noted above, the HW and CHW pumps are beyond their useful life and should be considered for replacement with new pumps including Variable frequency drives (VFD). VFDs allow the pumps to vary the flow rate to match the demand. This recommendation is an energy saving measure and does not affect the indoor air quality of the building.

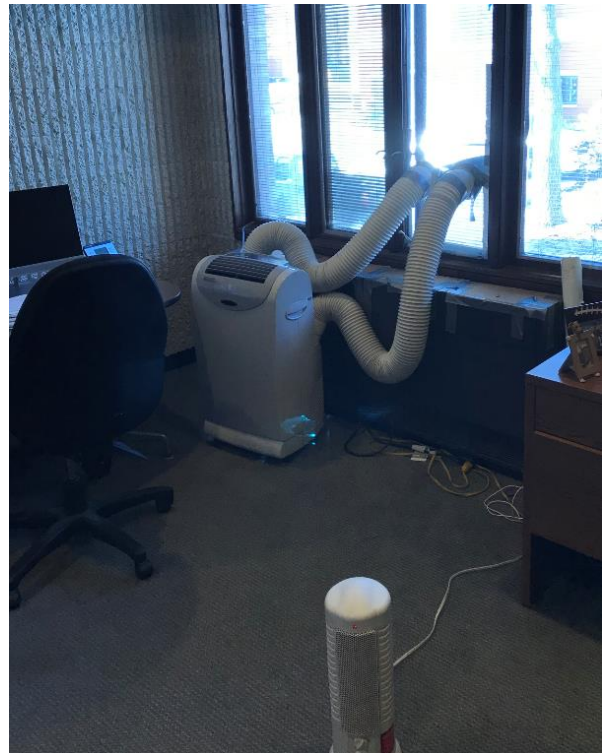
Photo 4 – Typical FCU / Portable Heat Pump

According to staff the dual temp system which serves all the FCUs throughout the perimeter of the building has been isolated and shut off due to leaking pipes which would cause flooding throughout the building. These fan coil units are the main source of heating, cooling and ventilation for the perimeter offices, conference rooms and open work areas which are regularly occupied by the staff in the building. Building facilities has placed portable heat pumps throughout these spaces which provide some heating and

cooling but do not provide any ventilation air. These units have a heating capacity of 11 MBH and are in spaces where the original fan coil units had heating capacities ranging from 20-35 MBH. It is noticeably cold in many of these spaces and it was reported that building staff often wear jackets in order to stay warm throughout the workday. In order to restore basic comfort as well as recommend ventilation to these normally occupied areas, we recommend addressing this issue as soon as possible. See the Other Recommendations section below for more information.

As mentioned in Section 1.1, the dual temp system which serves all of the fan coil units around the perimeter of the building as well as the unit ventilator in the Jury Pool Room has been shut off due to leaking which causes flooding in the building. These FCUs serve offices, conference rooms and open work areas which are regularly occupied by the staff in the building. This leaking issue should be investigated and repaired as soon as possible in order to restore basic comfort and ventilation to these areas of the courthouse.

As mentioned in Section 1.1, the fan coil units are well beyond their useful life at 45 years old. These units should be considered for replacement either with similar window mounted fan coil units or with a new overhead system. We recommend performing a study to determine a feasible, cost effective and efficient system to replace these fan coil units and restore basic comfort and ventilation to these areas.

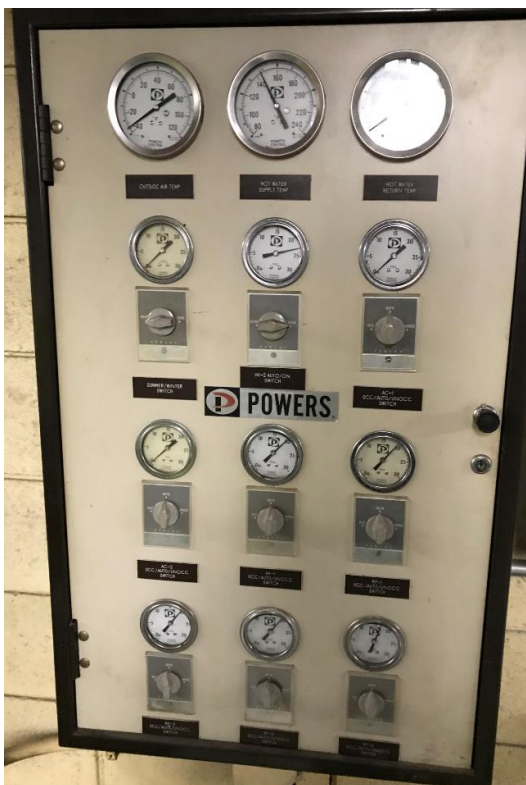
Photo 5 – Pneumatic Control Panel

The Peabody District Courthouse does not have a Building Management System (BMS) for controlling the mechanical systems. All the mechanical equipment is controlled using local controls. A large amount of the controls, including control valves, damper actuators, thermostats, etc. are pneumatic. These pneumatic controls are original to the building and beyond their useful life to the point of becoming obsolete. The air compressor serving the pneumatic system is original to the building and well beyond its useful life.

As renovations have happened over the years, particularly the 2006 HVAC renovation, electric valves, damper actuators and thermostats have replaced some of the pneumatics, however, a large portion of the systems still use pneumatic controls.

We recommend replacing the pneumatic control system with a Building Management System to control and monitor HVAC equipment. Pneumatic air systems are antiquated and do not offer the same benefits as a BMS. This recommendation is an energy saving and maintenance measure and does not affect the indoor air quality of the building.

We recommend replacing pneumatic damper and valve actuators with electronic actuators and tying them into the Building Management System. Pneumatic controls is an old and obsolete technology. These systems tend to leak air, may result in poor control of the HVAC equipment, cause the air compressor to run more frequently and increase energy usage. A BMS can monitor the position of electronic valves, trend valve position data, and report alarms.
